#### VIBRATION RESPONSES OF SIMPLE CURVED PANELS TO

#### HIGH-INTENSITY RANDOM AND DISCRETE

FREQUENCY NOISE

Carl E. Rucker

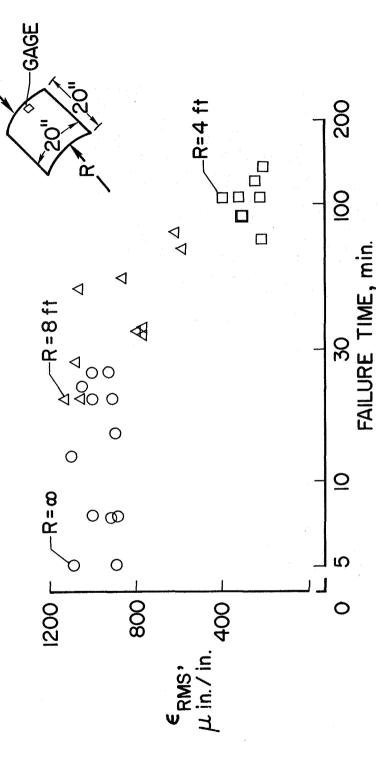
Sonic fatigue data are shown in figure 1 for three different panel curvatures for comparison. Root-mean-square strain for a strain gage near the panel edge is plotted as a function of time to failure in minutes. The excitation was a broadband random noise from an air jet. Its overall sound pressure level was 155 decibels and the spectrum peaked sharply at about 100 Hz (see refs. 1 and 2). Identical 20- by 20-inch sheets of material were formed to curved fixtures with lap attachments. Three-sixteenth-inch A&N bolts and nuts adjusted to a given torque were spaced on  $1\frac{1}{2}$ -inch centers with 5/8-inch edge distance. By this means, an attempt was made to minimize the edge-attachment condition differences for the test panels.

One of the main results of the above study was the relatively short times to failure of the 4-foot-radius panels even though the measured strain levels were markedly lower than for the other curvatures. It was originally suggested that significantly different stress concentration factors may have existed. The present paper, however, contains results of other studies relating to the dynamic behavior of the 4-foot-radius panel and which may also be significant in causing shorter times to failure.

Figure 1.- Time to failure for 0.020-inch-thick aluminum-alloy panels of three curvatures in a random noise field having an overall sound pressure level of 160 dB.

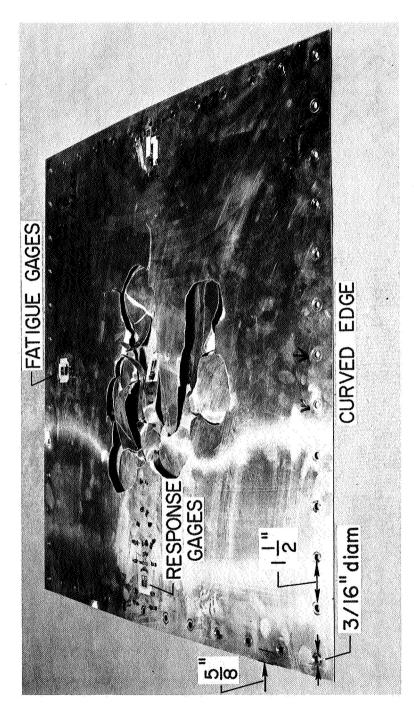
Figure 2 is a photograph of a panel which failed due to sonic fatigue while formed into a 4-foot-radius configuration. It is believed that this failure resulted from test conditions for which the panel was buckled. Since buckling is a strong indicator of nonlinear behavior, the panel response was studied for other evidence of nonlinearities.

Figure 2.- Photograph of 0.020-inch-thick aluminum-alloy panel of h--foot radius after sonic fatigue failure due to siren excitation.

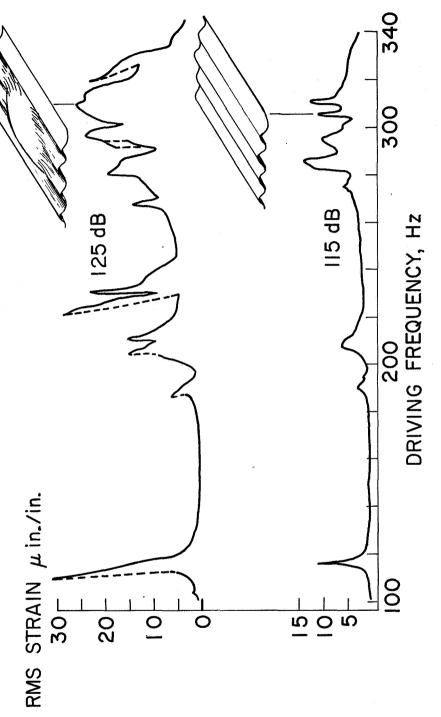
A series of dynamic response studies involving different intensities of acoustic loading were conducted, and some representative results are presented in figure 3. Overall root-mean-square strains are plotted as a function of discrete driving frequency for sound-pressure levels of 115 and 125 dB impinging on the lower surface of the panel. At the lower excitation level the panel appeared to be responding generally as a linear system. At the higher level, however, there was definite evidence of nonlinear response. The skewness of the response peaks toward lower frequencies represents a soft spring effect; that is, the panel becomes less stiff at large vibration amplitudes.

The mode shape sketches on the figure illustrate qualitatively the modal pattern variation for these two levels of excitation. The sketch at the top suggests a buckling condition such that the center portion of the panel experiences relatively large amplitude motions at frequencies other than the driving frequency.

Figure 3.- Overall strain responses of a 4-foot radius panel as a function of driving frequency for two different levels of discrete frequency excitation.

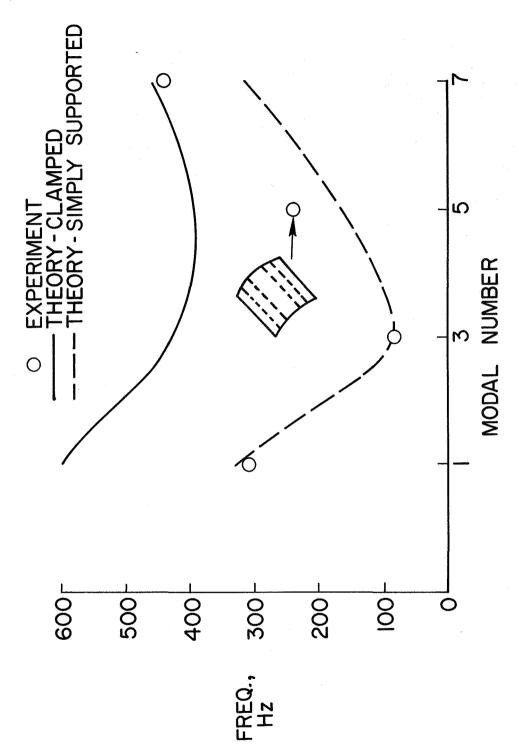
Both analytical and experimental studies have been made for the modal response of this panel, and the results are presented in figure 4. Frequency in Hz is shown for various modal numbers (number of antinodes). Theoretical calculations assuming both clamped and simply supported boundary conditions (ref. 3) are represented by the solid and dashed curves, respectively. Experimental data obtained using discrete frequency excitation are represented by the circle points. They seem to fall close to the simply supported values at low modal numbers and close to the clamped values at high modal numbers. Note that the frequency for the fundamental mode corresponds closely to that of the sixth mode. As indicated in figure 3, the sixth mode only was excited at a level of about 115 dB, whereas at a 120-dB level and higher, the panel snapped into a

buckled condition for which the fundamental and sixth modes are superimposed (see upper sketch of fig. 3).

Figure h.- Some modal responses of curved aluminum panel (R = h ft) excited by discrete frequency noise.

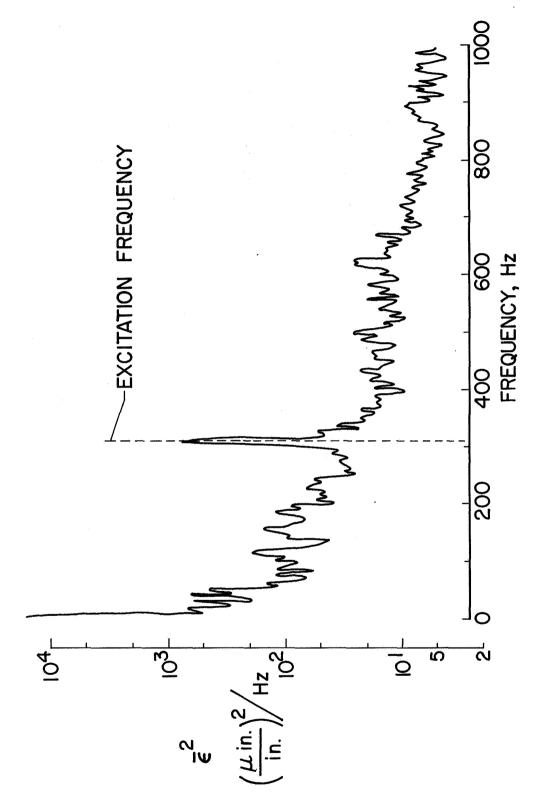
Additional panel response data for high levels of noise excitation are presented in figures 5 and 6.' In figure 5 the mean square bending strains are shown as a function of frequency. The discrete frequency excitation (at a 145-dB level) was provided by a siren for which the harmonic content was at least 40 dB lower in level than the excitation frequency of the figure. The data shown were obtained by means of a 15-second tape loop and narrow band filters. Note that relatively strong responses of the panel occur at frequencies lower than the exciting frequency.

Figure 5.- Spectrum of bending strain response of 4-foot radius curved panel due to discrete frequency excitation at 145-dB sound pressure level.

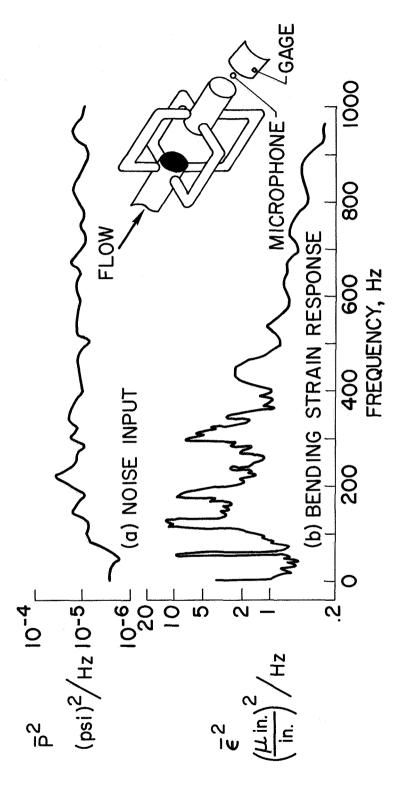
The response of the panel to broadband noise is shown in figure 6. Again, mean-square bending strain per unit bandwidth is plotted as a function of frequency. The spectrum shape of the 150-dB level random noise is shown at the top of the figure. Note that this nearly flat random noise spectrum was generated by a unique jet turbulator nozzle represented by the sketch at the right. A number of relatively strong responses are observed at the low frequencies even in the range where the input spectrum tends to drop off. These latter response data are thus consistent with those of figure 5.

Figure 6.- Bending strain response spectrum of a 4-foot radius panel due to random noise input from a four-branch air jet noise source.

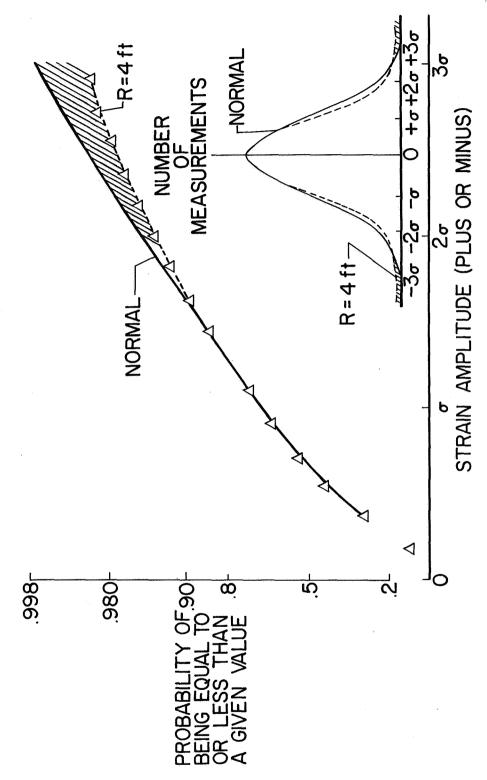
Sample strain amplitude distribution data as measured with the pulse-height analyzer are presented in figure 9 for the 4-foot-radius panel. The distribution shown is for a sound-pressure level of 157 dB and contains over 79,000 samples. Also shown is a solid curve representing a normal or gaussian distribution. The probability of being equal to or less than a given value of strain is plotted on the vertical scale for various multiples of standard

deviation ( $\sigma$ ). It can be seen that the measured data generally follow the normal distribution curve up to nearly  $2\sigma$  and then deviate from the normal distribution curve at higher values. This result implies that a greater percentage of the panel lifetime is spent at strain values above  $3\sigma$  than would be the case for a normal distribution of strain amplitudes. Although not shown on the figure, similar data for the other two panel curvatures of figure 1 fell generally along the gaussian curve at the higher  $\sigma$  values. The implication from these data is that the 4-foot curvature panel, probably because of its nonlinear behavior characteristics, experienced an abnormally high number of high strain values. These strain peaks may account for the shorter times to failure of these panels.

Figure 9.- Total strain amplitude distribution for 4-foot radius panel due to random noise loading compared to a normal distribution.
